Kilworthy Farm

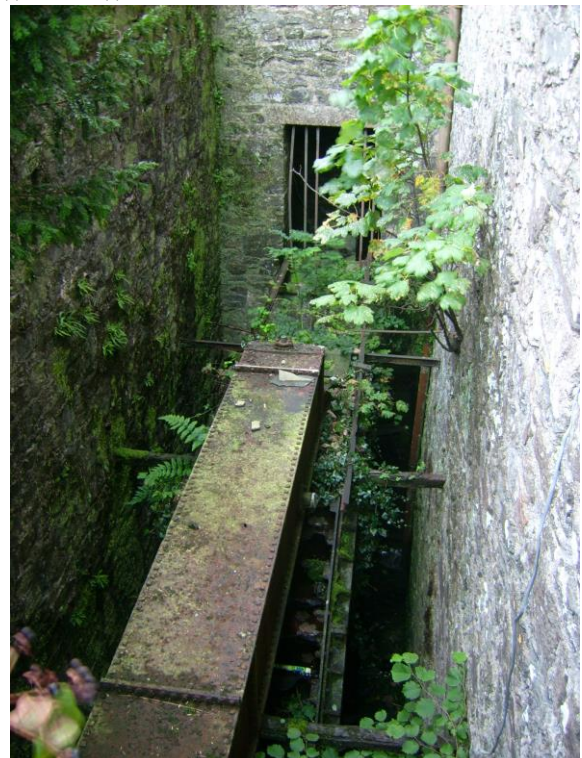
Water wheel pit

A leat taking water from the River Wallabrook was dug and a wheel pit and exit culvert excavated. The large water wheel (9.09m or 30feet diameter by 1.08m or 3feet 6inches wide) was purchased from a millwright and engineer Oliver Maggs in Dorset and installed by him, it was built entirely of cast and wrought iron and a system of shafts and bevel gears transferred power onto the horizontal lay shaft visible in the upper storey of the granary /machinery barn.

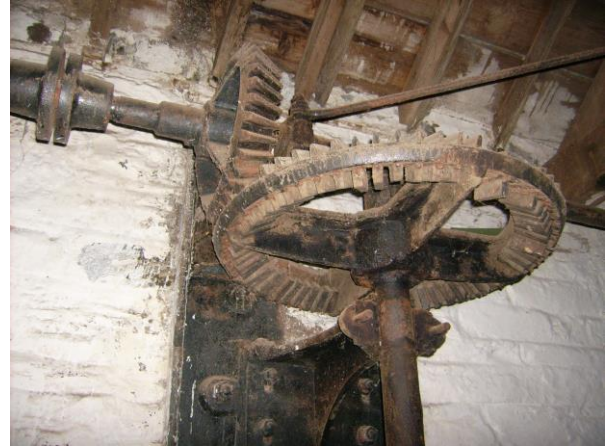
On the first floor you can see two low doorways in the west wall which give high level access to the north and south cow houses, probably for passing feed or straw. The floorboards had steel tongues inserted between them which gave a solid clean floor surface. Some boards are of exceptional length being of Baltic or Canadian Pine. Three large trap doors are situated in the centre of the floor whilst five on the west side serve

spouts that project from the ceiling of the ground floor and indicate probable positions of feed-processing

machines. The roof has nine bays with eight king post trusses with pairs of glass roof lights in the three central bays. The horizontal layshaft is over 18m. long and is hung from the east end of each of the truss tie beams and carries seven pulleys of varying sizes.

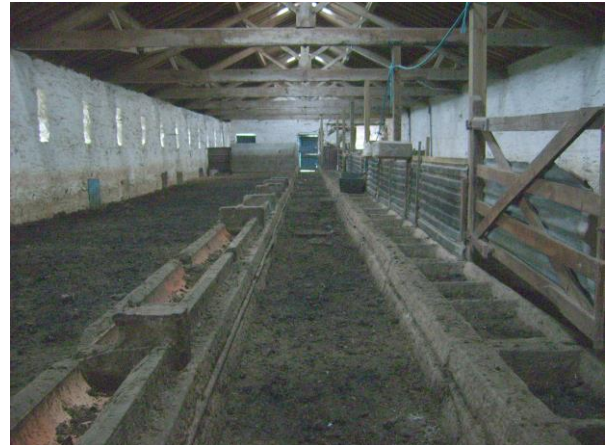
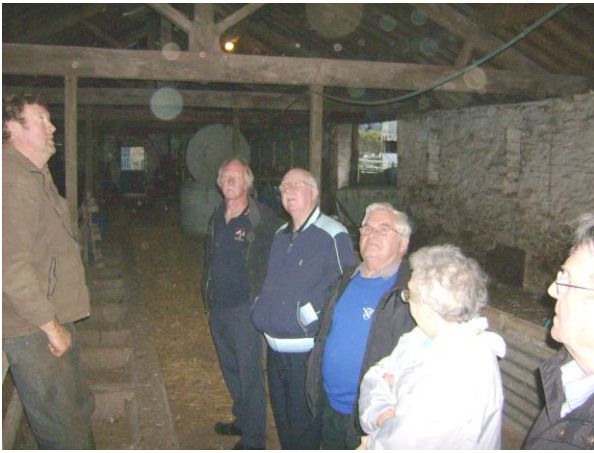
Three parallel ranges run west to east showing symmetrical design, the central cow house being narrower than the outer two. Around the outside north and west walls of the cow houses you can see openings to chutes, protected by iron grill covers, for taking dung into the undercroft below. Through each of the outer cow houses run parallel sets of carved granite troughs on either side of a central walkway. The central trough in each triple was for water and has an iron feeder pipe which is believed to have been gravity fed. Inside each cow house there are dung chutes again leading to the undercroft. Some retain cast iron frames which originally had hinged wrought iron plates which closed the chute when vertical. The roof again is similar to the granary and machinery barn with king post trusses, close boarding and pairs of glass roof lights. The windows in the outer cow houses consist of vertical ventilation/light slits regularly spaced along the north and south outer walls. Above the central door of each cow house there is a louvered opening operated by turning a vertical rod similar to the louvers in the granary/machinery barn. The central cow house is divided by a cross-wall which originally had double sliding doors on its east side. The three bays at the east end are divided into pens made up of the original iron

rails and gates on either side of the central walkway. These pens are understood to have been for veal production. Oval openings in the floor of pens and walkway allowed dung to be pushed through to the undercroft when their perforated iron covers were removed. Ventilation had to be particularly well planned in the central cow house as apart from the louvers in the west wall it had no outside walls /windows. This was achieved by building a set of ridge ventilators. Flue vents were also built above the doors at the east end of each cow house and also in the cross wall of the central cow house. The central cow house was also whitewashed.

In order to drain the rainwater from the north valley gutter, it was carried across the central cow house from north to south by means of three launders. These are open top timber troughs lined with sheet metal and can be seen in the central cow house. The water then fed into cast iron downpipes taking it to the drains below the undercroft floor.

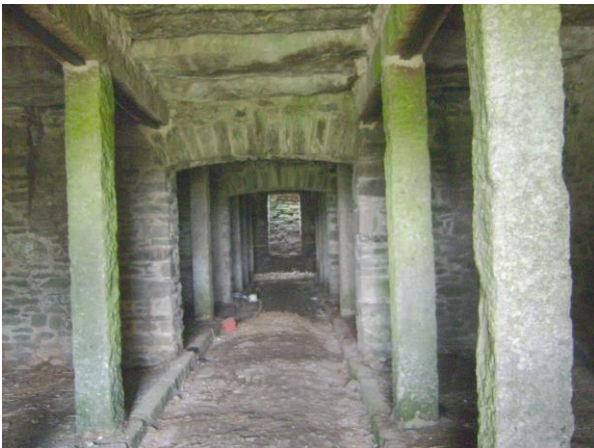
This extends the full width and length of the cow houses above. The cow house floors are carried on a post and lintel construction all formed in granite with massive slabs of varying width being carried on lintels supported on granite columns. Each lintel has a wrought iron strap along its underside turned up at either end of the lintel. It is understood that the strap gives a second line of defence should the lintel crack. In each of the 5 bays of the undercroft between the two rows of granite columns, there is a central aisle, bordered by granite curb stones. On either side the

dung collected on the raised areas, ready for carting onto the fields.
